Vehicle identification number (VIN): WP0ZZZY14PSA32093
Order type: Taycan 4S (MY23) (Y1ADB1)
Model year: 2023

HISTORIE OPRAV VOZIDLA V243813 **EL8 69D, Taycan 4S**

CERTIFIKÁT BATERIE

AVILOO
BATTERY DIAGNOSTICS

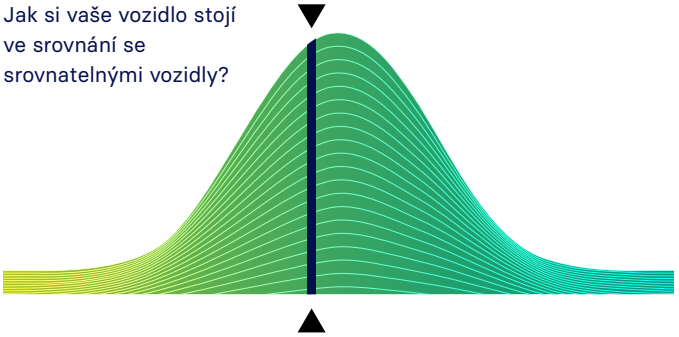
SROVNÁNÍ
Jak si vaše vozidlo stojí ve srovnání se srovnatelnými vozidly?

Nezávislý
ZDRAVOTNÍ STAV (SOH)

93,2 %

DOBRÝ STAV – NEBYLY ZJIŠTĚNY ŽÁDNÉ ANOMÁLIE
